**Thermography Inspection for Electrical Equipment
at

**Thermal Inspection for Electrical Equipment
Using Advanced FLIR T640 Thermal Camera**

Customer: *****

18/6/2014

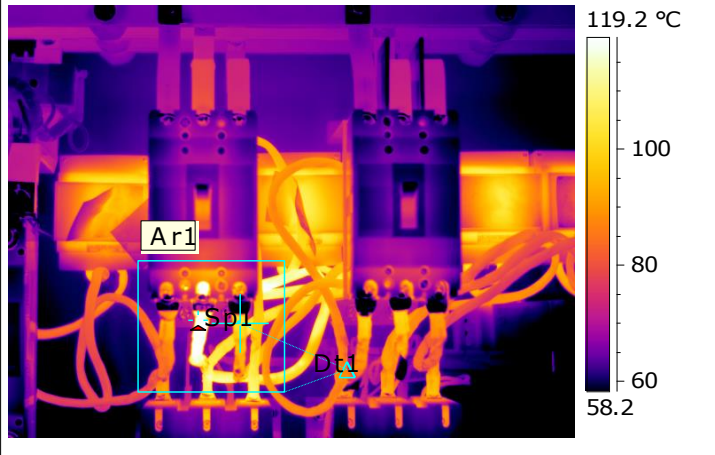
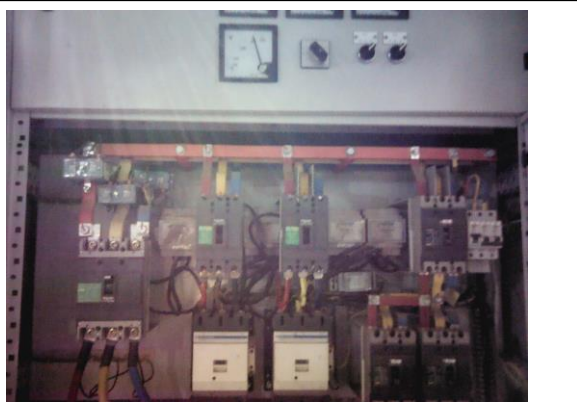
Location	South Under Al-Safeyah Bridge
Equipment	M-16

Ar1 Max. Temperature	136.9 °C
Sp1 Max. Temperature	102.2 °C
Dt1 Value	34.7 °C

Severity Rating & Recommendation			
1	Low ($\Delta = 5-10^{\circ}\text{C}$)	To be monitored	<input type="checkbox"/>
2	Medium ($\Delta = 10-35^{\circ}\text{C}$)	Repair at schedule outage	<input checked="" type="checkbox"/>
3	High ($\Delta > 35^{\circ}\text{C}$)	Repair immediately	<input type="checkbox"/>

The detected hot spot in thermal image shown above were many critical faults in filters and cables (Ar1) which are high in temperature.

In maximum load, this insulated conductor, enclosure surface (Ar1 of thermal image) model reference temperature should not exceed 50°C.

To check the loading current (in Amperes) of the secondary load side wire of the circuit breaker (S phase)
Do another thermal inspection

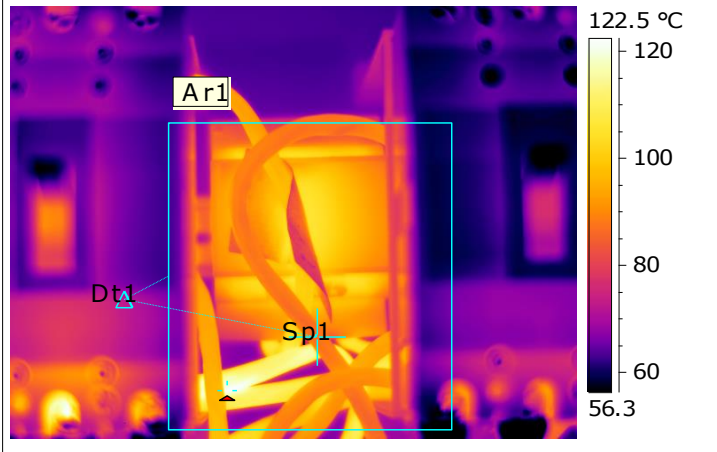
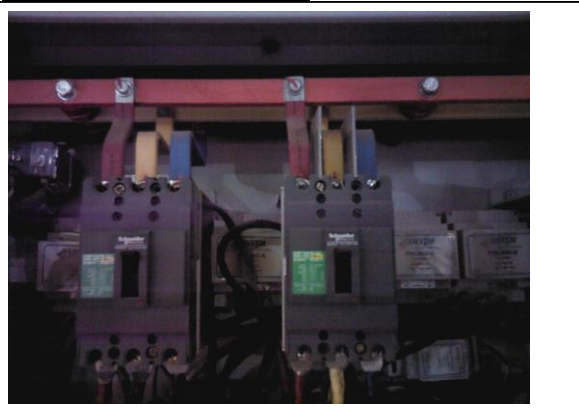
Location	South Under Al-Safeyah Bridge
Equipment	M-16

Ar1 Max. Temperature	122.5 °C
Sp1 Max. Temperature	87.0 °C
Dt1 Value	35.5 °C

Severity Rating & Recommendation			
1	Low ($\Delta = 5-10^{\circ}\text{C}$)	To be monitored	<input type="checkbox"/>
2	Medium ($\Delta = 10-35^{\circ}\text{C}$)	Repair at schedule outage	<input type="checkbox"/>
3	High ($\Delta > 35^{\circ}\text{C}$)	Repair immediately	<input checked="" type="checkbox"/>

The detected hot spot in thermal image shown above were many critical faults in filters and cables (Ar1) which are high in temperature.

In maximum load, this insulated conductor, enclosure surface (Ar1 of thermal image) model reference temperature should not exceed 50°C.

To checked the loading current (in Amperes) of the secondary load side wire of the circuit breaker (S phase)
Do another thermal inspection

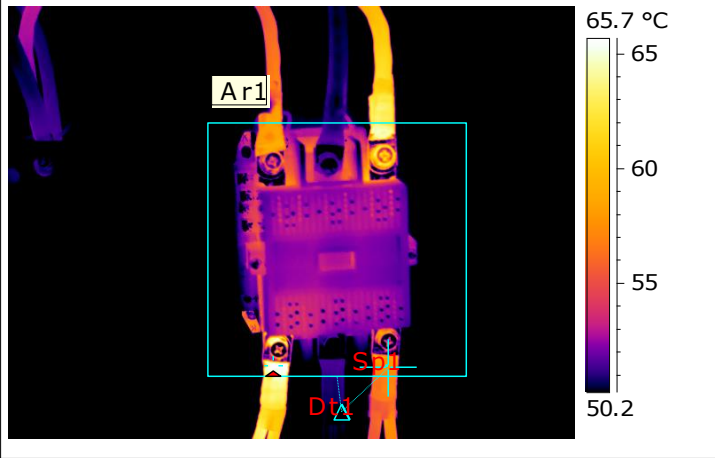
Location	South Al-Safeyah Garden
Equipment	M-10

Ar1 Max. Temperature	65.9 °C
Sp1 Max. Temperature	57.8 °C
Dt1 Value	8.2 °C

1	Low ($\Delta = 5-10^{\circ}\text{C}$)	To be monitored	<input checked="" type="checkbox"/>
2	Medium ($\Delta = 10-35^{\circ}\text{C}$)	Repair at schedule outage	<input type="checkbox"/>
3	High ($\Delta > 35^{\circ}\text{C}$)	Repair immediately	<input type="checkbox"/>

The detected hot spot in thermal image shown above was the secondary load side wire of the magnetic contactor (R phase) (Ar1) which is high in temperature.

In maximum load, this insulated conductor, enclosure surface (Ar1 of thermal image) model reference temperature should not exceed 50°C.

It is recommended to keep it under monitoring and to checked the load current in R phase of the contactor
Do another thermal inspection

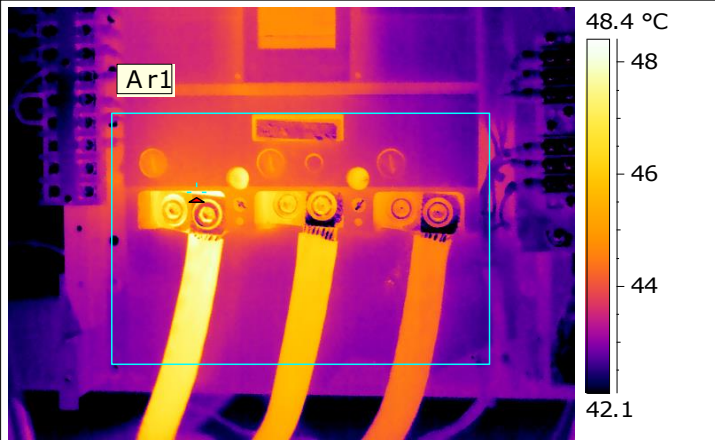
Location	South West-Versus of Dates Market
Equipment	M-6

Ar1 Max. Temperature	48.4 °C
----------------------	---------

In maximum load, connectors and terminations (Ar1 of thermal image) model reference temperature should not exceed 90°C.

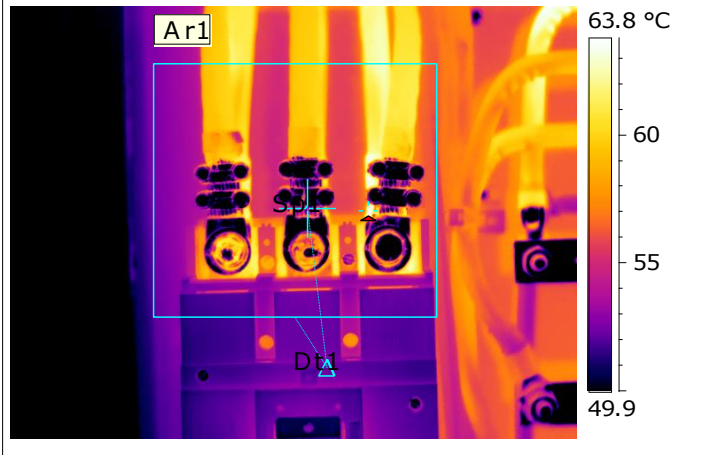
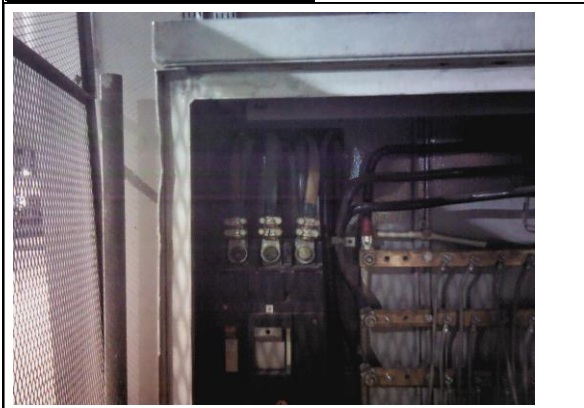
Location	South West-Under Al-Safeyah Bridge-Quba Signal
Equipment	M-15

Ar1 Max. Temperature	63.9 °C
Sp1 Max. Temperature	54.5 °C
Dt1 Value	9.4 °C

In maximum load, this connectors and terminations (Ar1 of thermal image) model reference temperature should not exceed 90°C.

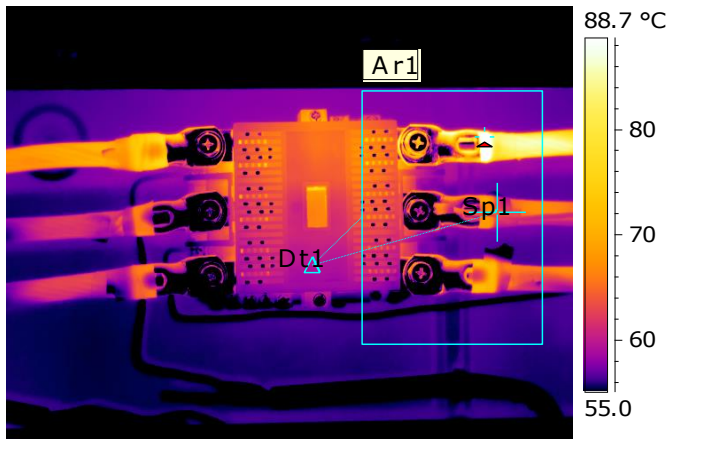
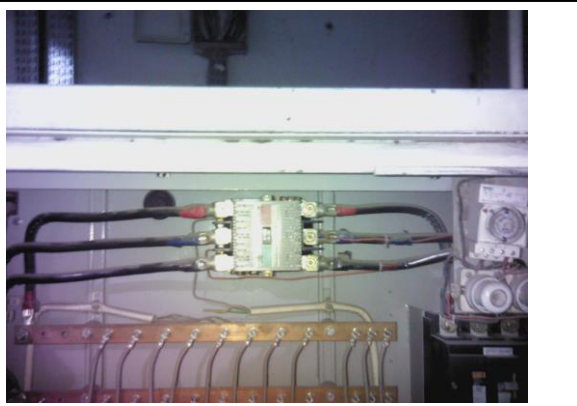
Location	South West-Under Al-Safeyah Bridge-Quba Signal
Equipment	M-15

Ar1 Max. Temperature	91.9 °C
Sp1 Max. Temperature	64.2 °C
Dt1 Value	27.7 °C

Severity Rating & Recommendation			
1	Low ($\Delta = 5-10^{\circ}\text{C}$)	To be monitored	<input type="checkbox"/>
2	Medium ($\Delta = 10-35^{\circ}\text{C}$)	Repair at schedule outage	<input checked="" type="checkbox"/>
3	High ($\Delta > 35^{\circ}\text{C}$)	Repair immediately	<input type="checkbox"/>

The detected hot spot in thermal image shown above was the secondary load side wire of the magnetic contactor (T phase) (Ar1) which is high in temperature.

In maximum load, this insulated conductor, enclosure surface (Ar1 of thermal image) model reference temperature should not exceed 50°C.

- To check the loading current of the secondary load side wire of the contactor (T phase)
- To check all cable terminations
- Do another thermal inspection

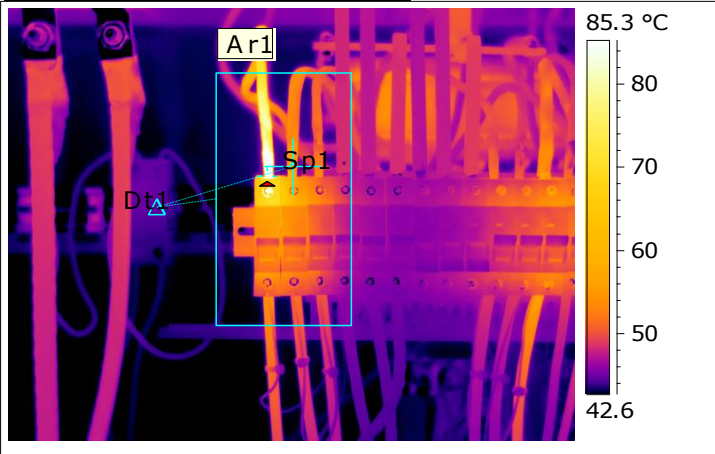
Location	Al-Anbareyah-Under(Harbi Bridge or the 60 bridge)
Equipment	The new panel

Ar1 Max. Temperature	95.6 °C
Sp1 Max. Temperature	57.6 °C
Dt1 Value	38.1 °C

Severity Rating & Recommendation			
1	Low ($\Delta = 5-10^{\circ}\text{C}$)	To be monitored	<input type="checkbox"/>
2	Medium ($\Delta = 10-35^{\circ}\text{C}$)	Repair at schedule outage	<input type="checkbox"/>
3	High ($\Delta > 35^{\circ}\text{C}$)	Repair immediately	<input checked="" type="checkbox"/>

The detected hot spot in thermal image shown above was the secondary load side wire of the miniature circuit breaker (R phase) (Ar1) which is high in temperature.

In maximum load, this insulated conductor, enclosure surface (Ar1 of thermal image) model reference temperature should not exceed 50°C.

- To check the loading current of the secondary load side wire of the contactor (R phase)
- To check all cable terminations
- Do another thermal inspection

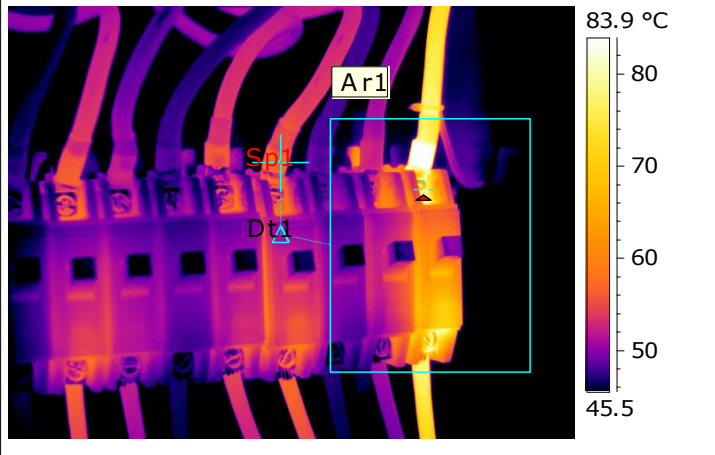
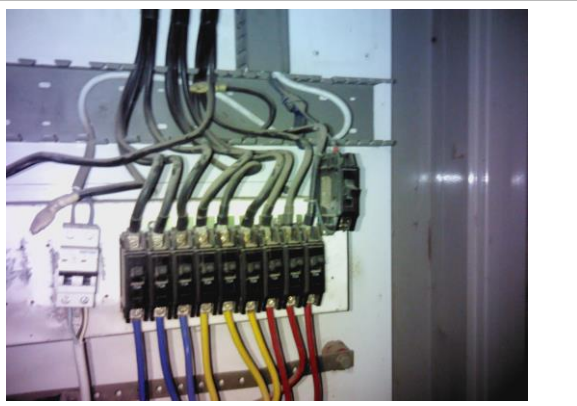
Location	The 60 Street-Al-Amarah-Versus of Marriott hotel
Equipment	M-13

Ar1 Max. Temperature	84.9 °C
Sp1 Max. Temperature	56.6 °C
Dt1 Value	28.3 °C

Severity Rating & Recommendation			
1	Low ($\Delta = 5-10^{\circ}\text{C}$)	To be monitored	<input type="checkbox"/>
2	Medium ($\Delta = 10-35^{\circ}\text{C}$)	Repair at schedule outage	<input checked="" type="checkbox"/>
3	High ($\Delta > 35^{\circ}\text{C}$)	Repair immediately	<input type="checkbox"/>

The detected hot spot in thermal image shown above was the secondary load side wire of the miniature circuit breaker (T phase) (Ar1) which is high in temperature.

In maximum load, this insulated conductor, enclosure surface (Ar1 of thermal image) model reference temperature should not exceed 50°C.

- To check the loading current of the secondary load side wire of the contactor (T phase)
- To check all cable terminations
- Do another thermal inspection

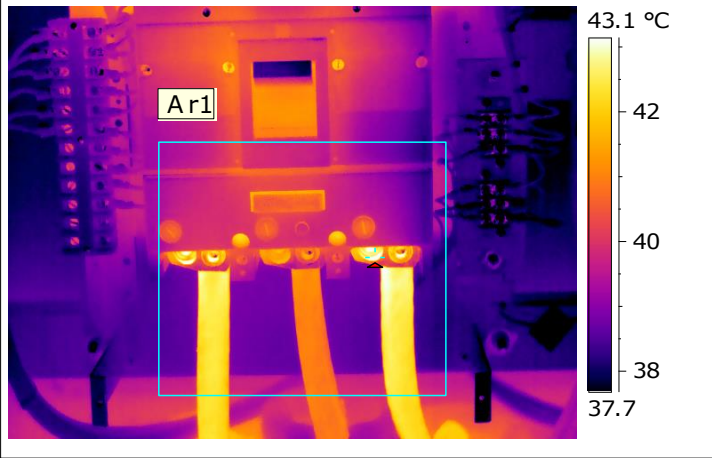
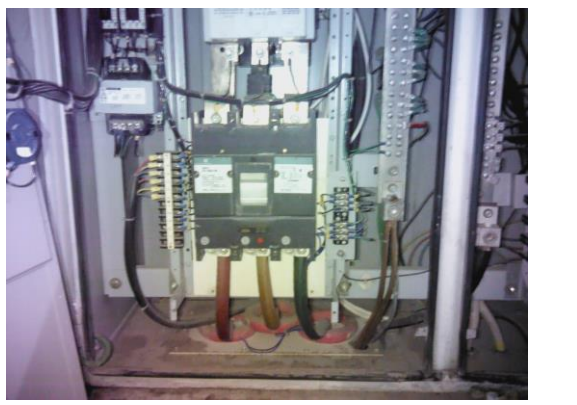
Location	South west-Near Abu Baker Al-seddeque mosque
Equipment	M-13

Ar1 Max. Temperature	43.5 °C
----------------------	---------

In maximum load, this connectors and terminations (Ar1 of thermal image) model reference temperature should not exceed 90°C.

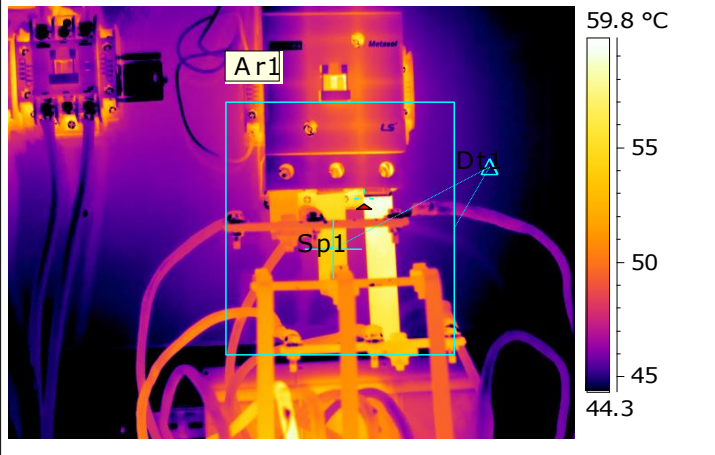
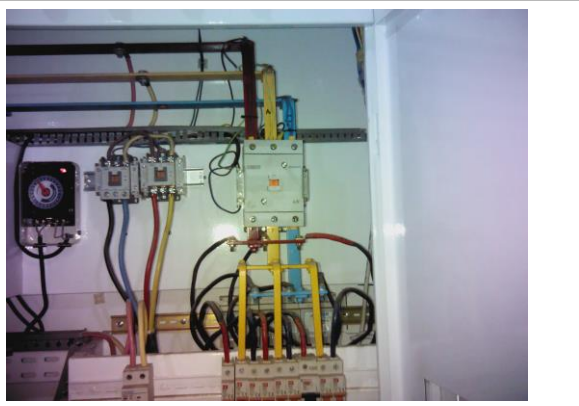
Location	West-Al-Salam Road- Wasel Al-Thahabe
Equipment	M-12

Ar1 Max. Temperature	59.1 °C
Sp1 Max. Temperature	53.8 °C
Dt1 Value	5.3 °C

In maximum load, this connectors and terminations (Ar1 of thermal image) model reference temperature should not exceed 90°C.
