WESAM SYSTEMS

Thermal Inspection for Mechanical Equipment

Using Advanced FLIR T640 Thermal Camera

Madinah, Saudi Arabia

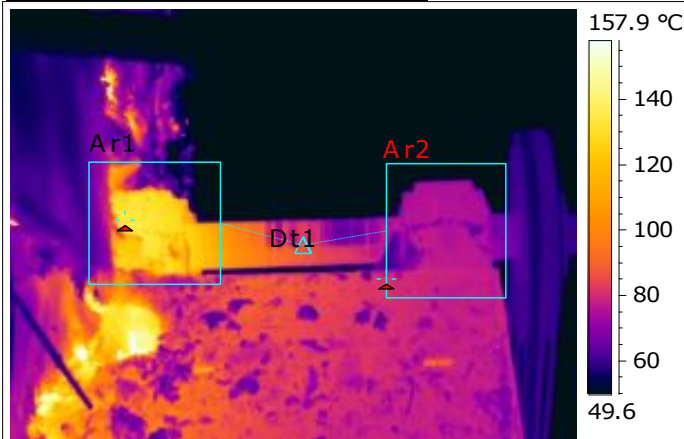
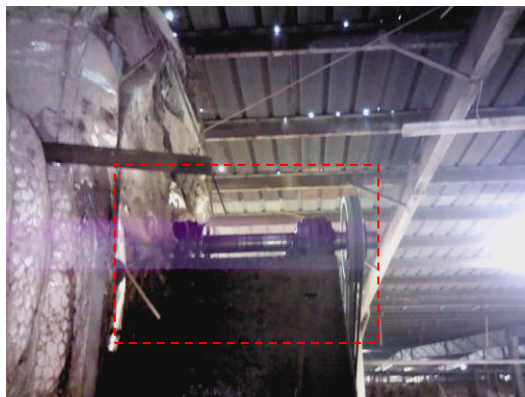
Location	Factory 2 – Kiln Area
Equipment	Recovery Fan

Ar1 Max. Temperature	135.1 °C
Ar2 Max. Temperature	81.4 °C
Dt1 Value	53.7 °C

Severity Rating & Recommendation			
1	Low ($\Delta = 5-10^{\circ}\text{C}$)	To be monitored	<input type="checkbox"/>
2	Medium ($\Delta = 10-35^{\circ}\text{C}$)	Repair as soon as schedule permits	<input type="checkbox"/>
3	High ($\Delta > 35^{\circ}\text{C}$)	Repair immediately	<input checked="" type="checkbox"/>

Impending bearing failure – which indicate overheating bearing / Out bearing problem

Recommendation: Generate a maintenance order to either replace the bearing or lubricate the bearing. While somewhat expensive and requiring an expert, vibration analysis can often help you determine the best course of action. Do another thermal inspection

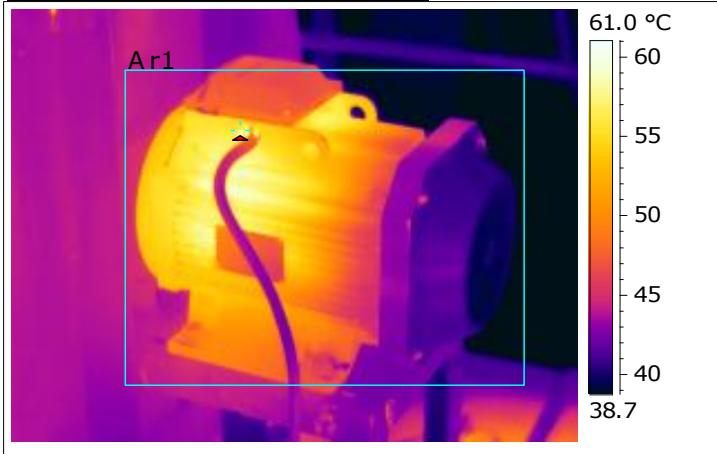
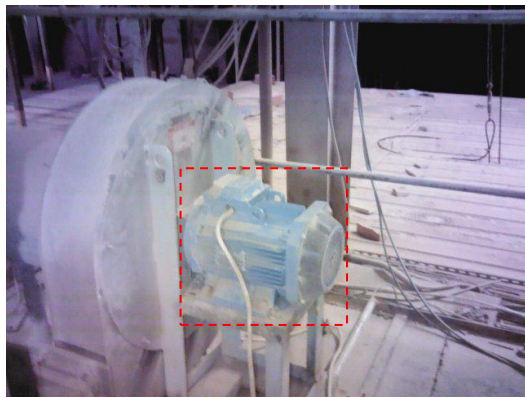
Location	Factory 2 – Rapid Cooling Area
Equipment	Motor 1

Ar1 Max. Temperature	60.1 °C
----------------------	---------

Recommendation: Nothing to do since the temperature reading was normal.

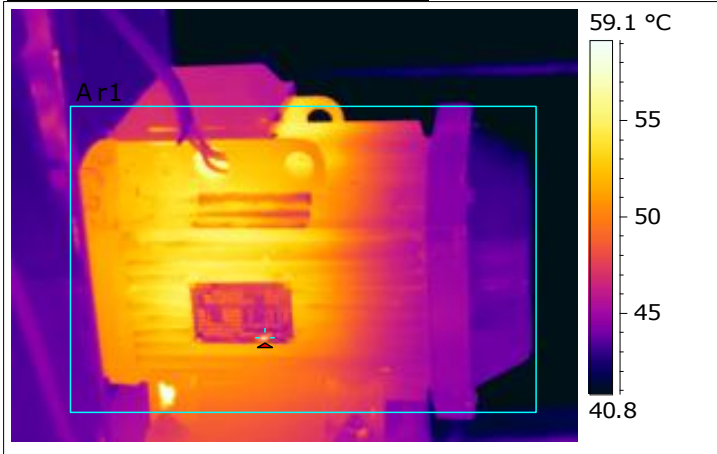
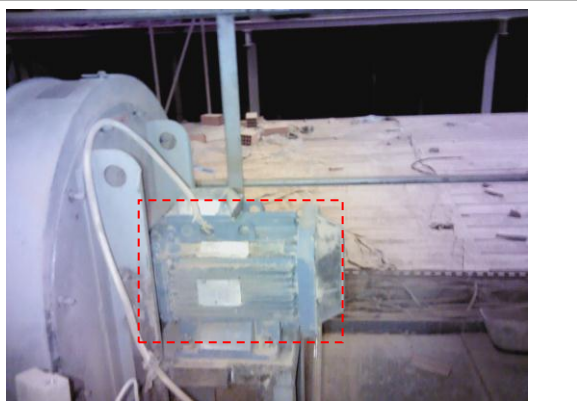
Location	Factory 2 – Rapid Cooling Area
Equipment	Motor 2

Ar1 Max. Temperature	73.6 °C
----------------------	---------

Recommendation: Nothing to do since the temperature reading was normal

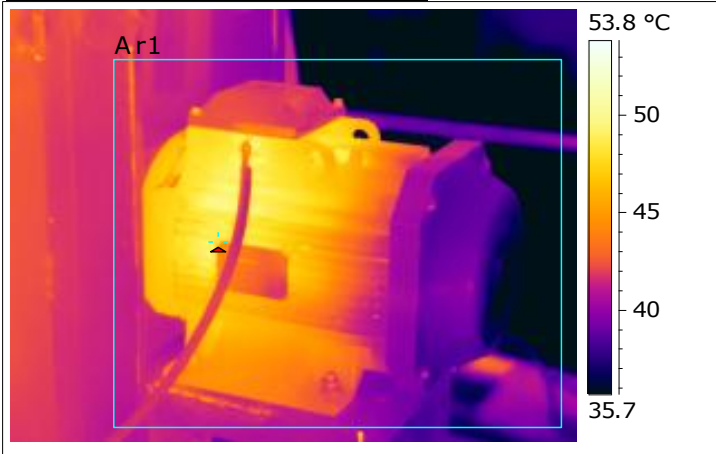
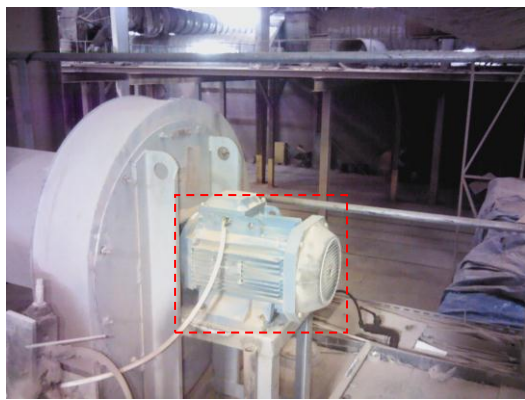
Location	Factory 2 – Rapid Cooling Area
Equipment	Motor 3

Ar1 Max. Temperature	52.1 °C
----------------------	---------

Recommendation: Nothing to do since the temperature reading was normal.

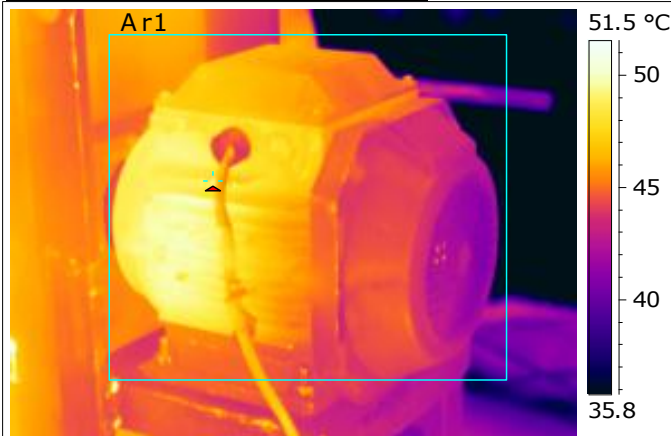
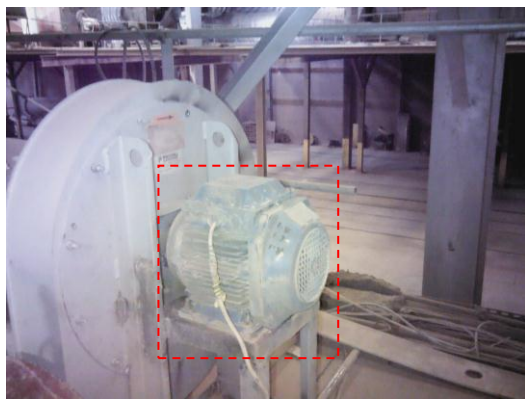
Location	Factory 2 – Rapid Cooling Area
Equipment	Motor 4

Ar1 Max. Temperature	51.9 °C
----------------------	---------

. Recommendation: Nothing to do since the temperature reading was normal

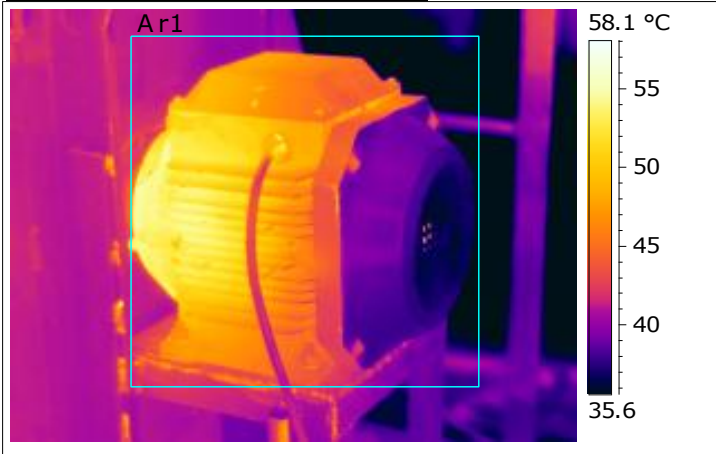
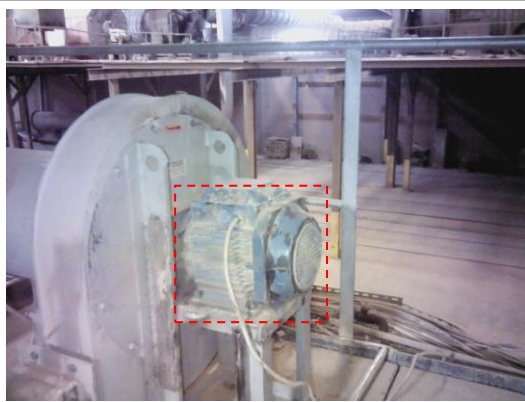
Location	Factory 2 – Rapid Cooling Area
Equipment	Motor 5

Ar1 Max. Temperature	61.2 °C
----------------------	---------

Recommendation: Nothing to do since the temperature reading was normal

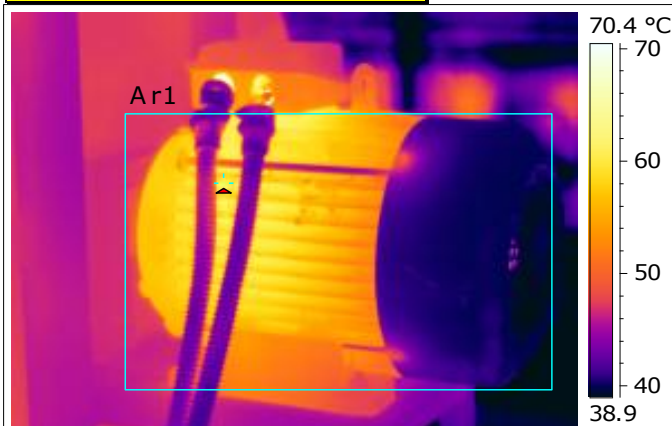
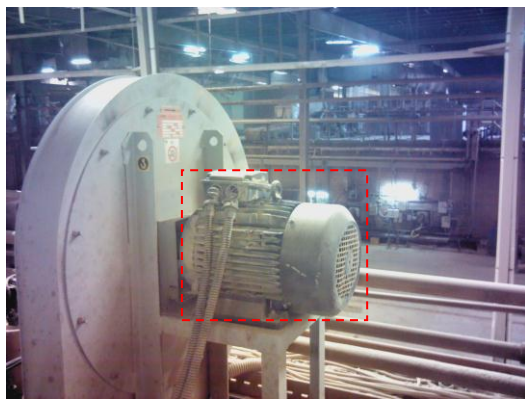
Location Factory 2 – Diesel Burners
Equipment Motor 1

Ar1 Max. Temperature 61.6 °C

. Recommendation: Nothing to do since the temperature reading was normal

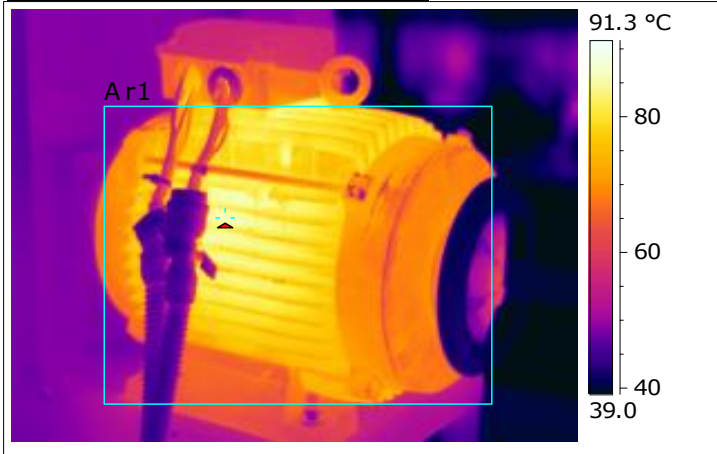
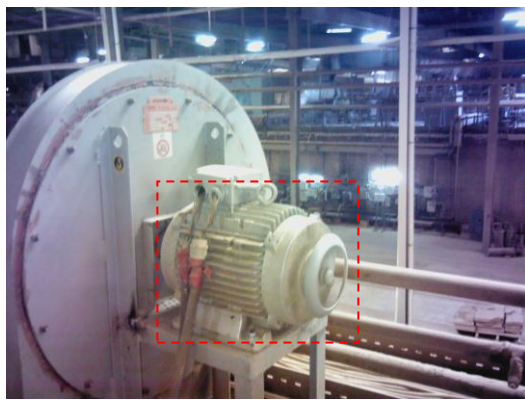
Equipment Motor 2

Ar1 Max. Temperature 86.0 °C

1	Low ($\Delta = 5-10^{\circ}\text{C}$)	To be monitored	<input checked="" type="checkbox"/>
2	Medium ($\Delta = 10-35^{\circ}\text{C}$)	Repair as soon as schedule permits	<input type="checkbox"/>
3	High ($\Delta > 35^{\circ}\text{C}$)	Repair immediately	<input type="checkbox"/>

Internal winding problem of motor

Recommendation: If motor is not equipped with installed sensors: record Stator temperature using thermographic imaging. This data should be trended. The monitoring should be completed at similar motor loading and ambient temperature to allow for accurate trending.

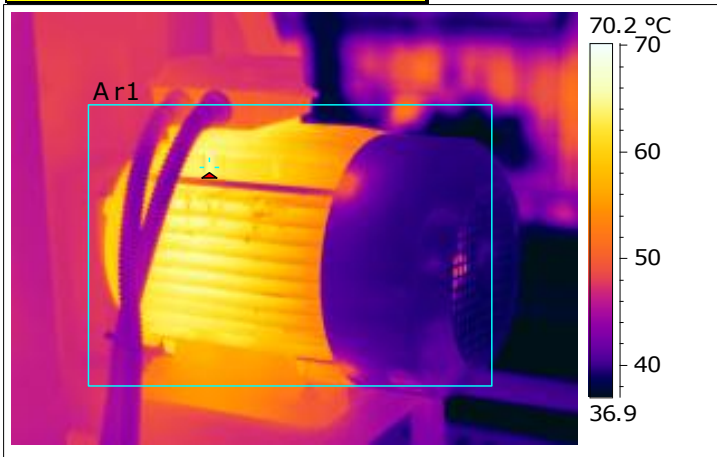
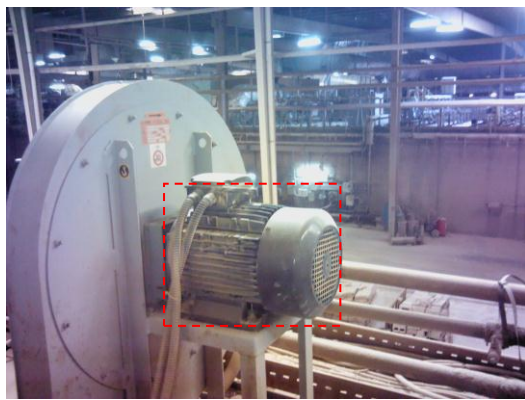
Location	Factory 2 – Diesel Burners
Equipment	Motor 3

Ar1 Max. Temperature	65.6 °C
----------------------	---------

Recommendation: Nothing to do since the temperature reading was normal

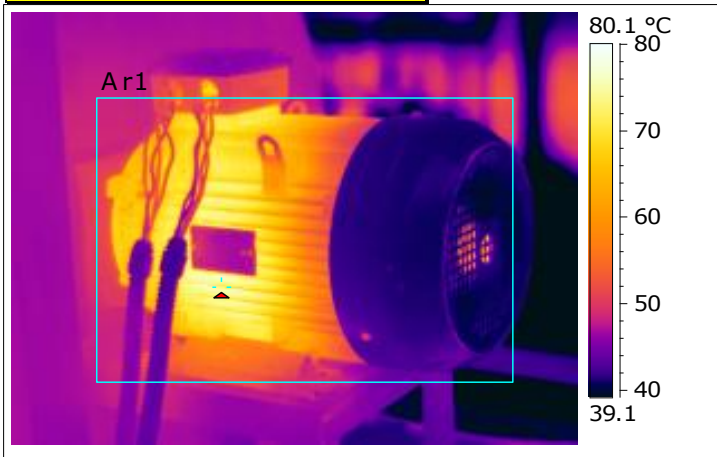
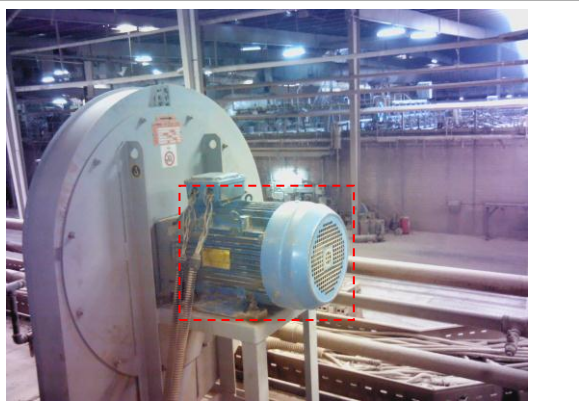
Location Factory 2 – Diesel Burners
Equipment Motor 4

Ar1 Max. Temperature 75.9 °C

. Recommendation: Nothing to do since the temperature reading was normal

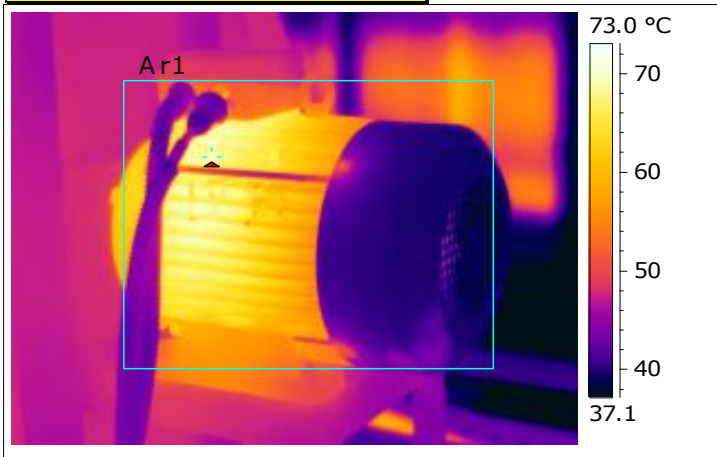
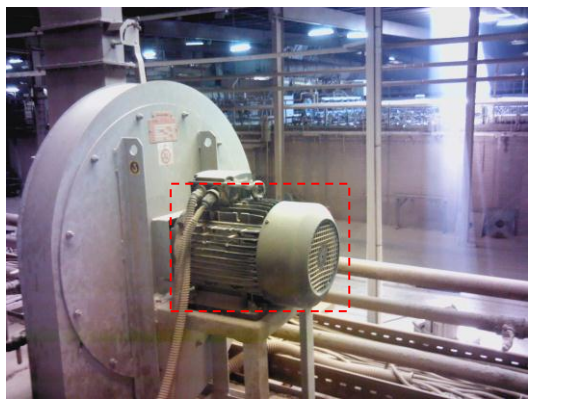
Location	Factory 2 – Diesel Burners
Equipment	Motor 5

Ar1 Max. Temperature	70.6 °C
----------------------	---------

Recommendation: Nothing to do since the temperature reading was normal

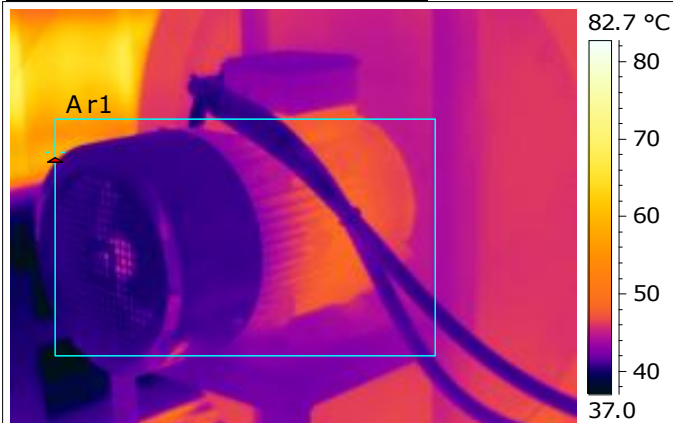
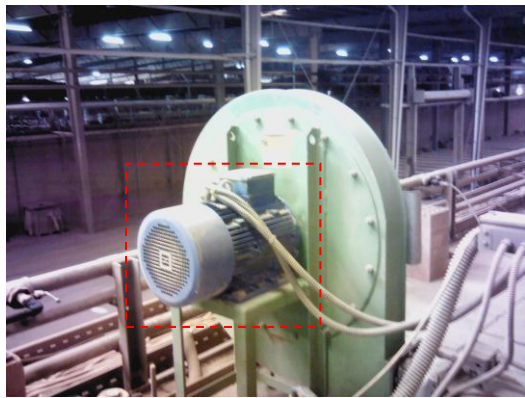
Location	Factory 2 – Diesel Burners
Equipment	Motor 6

Ar1 Max. Temperature	59.3 °C
----------------------	---------

Recommendation: Nothing to do since the temperature reading was normal

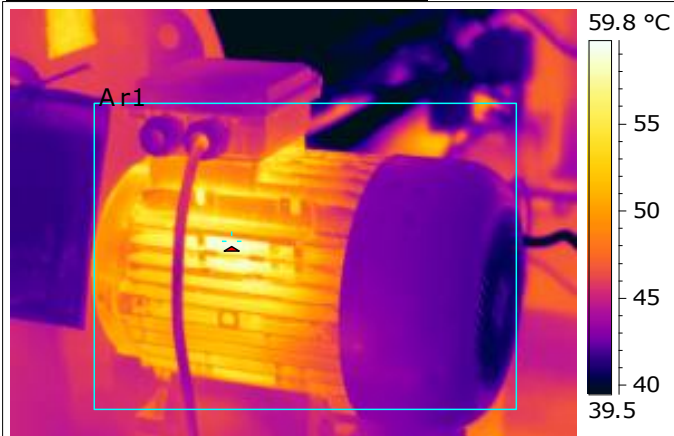
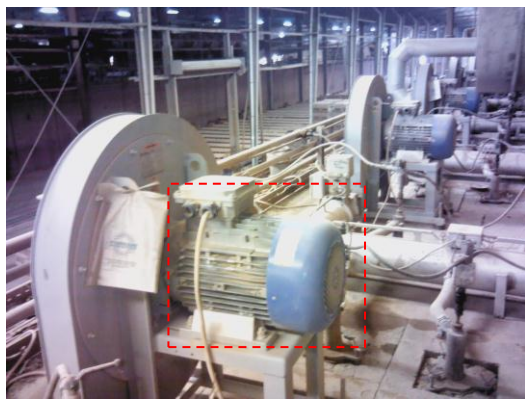
Location	Factory 2 – Diesel Burners
Equipment	Motor 7

Ar1 Max. Temperature	59.8 °C
----------------------	---------

Recommendation: Nothing to do since the temperature reading was normal.

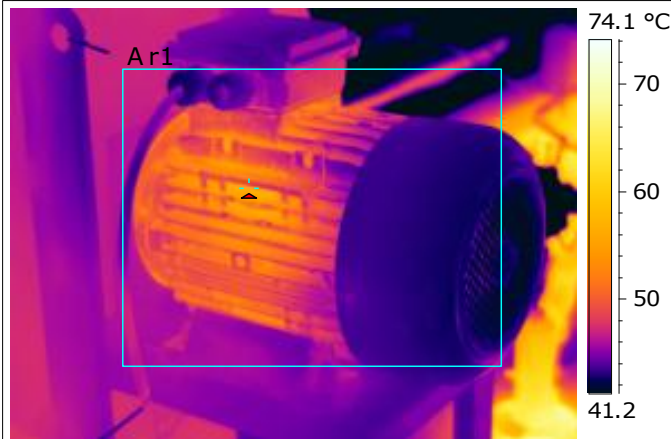
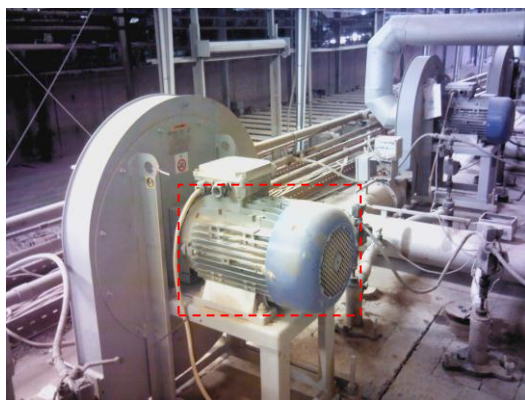
Location	Factory 2 – Diesel Burners
Equipment	Motor 8

Ar1 Max. Temperature	56.8 °C
----------------------	---------

Recommendation: Nothing to do since the temperature reading was normal

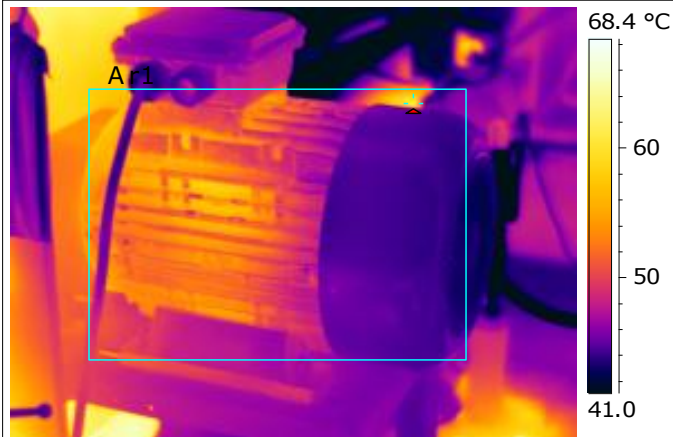
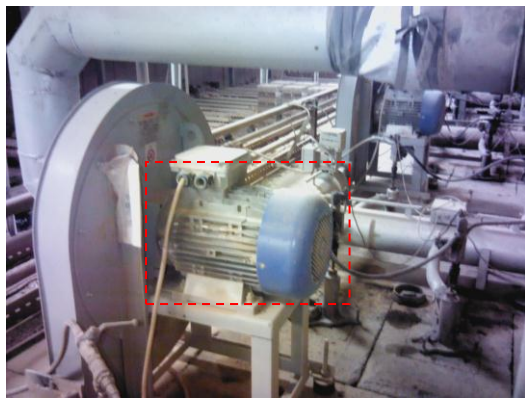
Location	Factory 2 – Diesel Burners
Equipment	Motor 9

Ar1 Max. Temperature	60.6 °C
----------------------	---------

Recommendation: Nothing to do since the temperature reading was normal

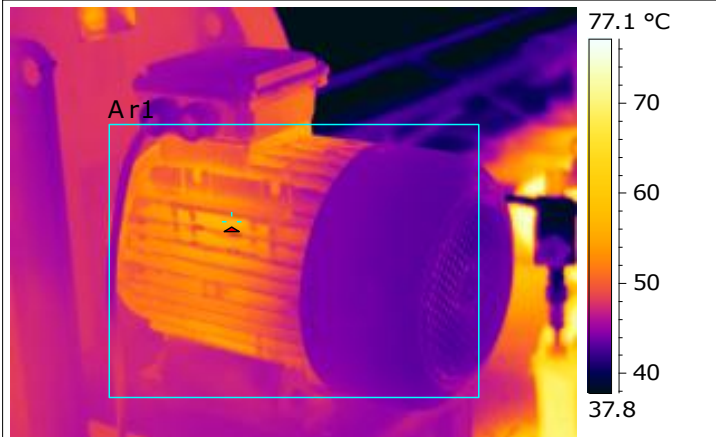
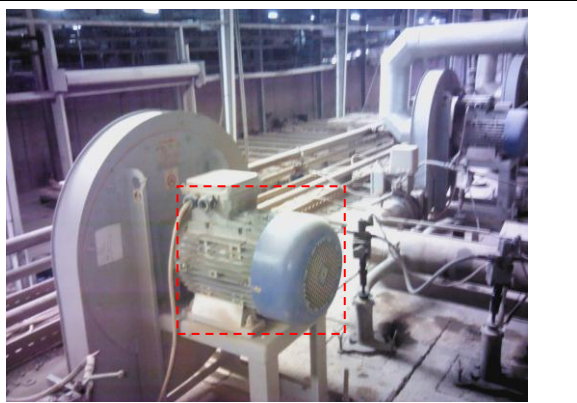
Location	Factory 2 – Diesel Burners
Equipment	Motor 10

Ar1 Max. Temperature	57.2 °C
----------------------	---------

. Recommendation: Nothing to do since the temperature reading was normal

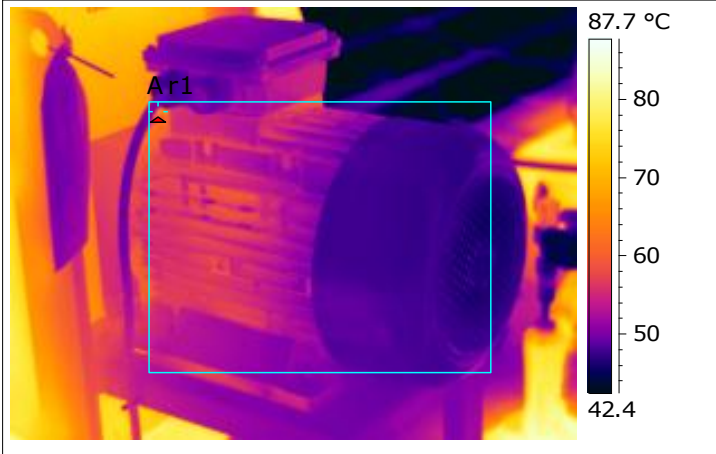
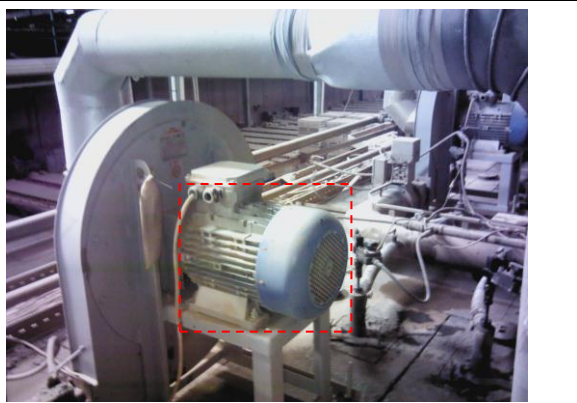
Location	Factory 2 – Diesel Burners
Equipment	Motor 11

Ar1 Max. Temperature	64.7 °C
----------------------	---------

. Recommendation: Nothing to do since the temperature reading was normal

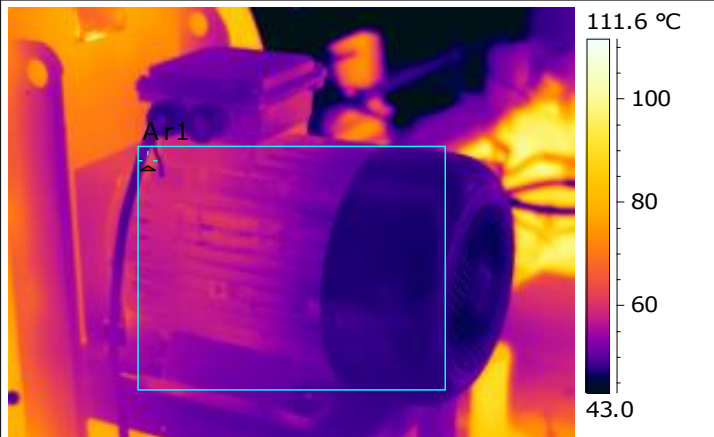
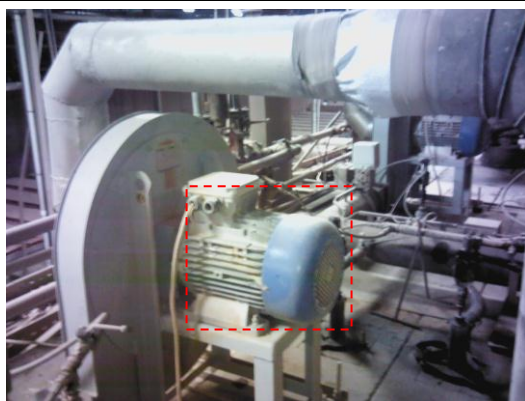
Location	Factory 2 – Diesel Burners
Equipment	Motor 12

Ar1 Max. Temperature	63.7 °C
----------------------	---------

. Recommendation: Nothing to do since the temperature reading was normal

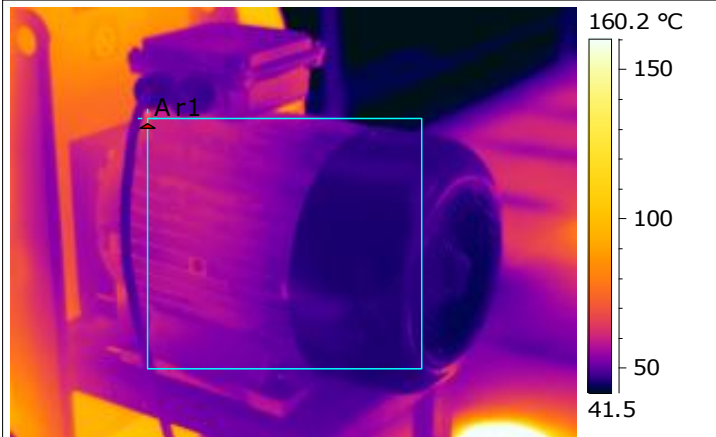
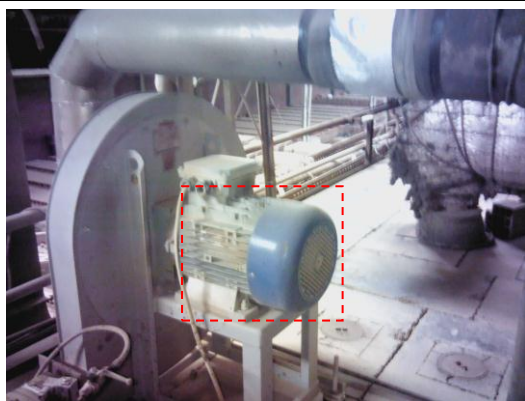
Location	Factory 2 – Diesel Burners
Equipment	Motor 13

Ar1 Max. Temperature	65.9 °C
----------------------	---------

. Recommendation: Nothing to do since the temperature reading was normal
