**Thermal Inspection for Electrical Equipment  
Using Advanced FLIR E60bx Thermal Camera**

**Customer:\*\*\*\*\***

**Location:\*\*\*\*\***

**2/3-5/2015**

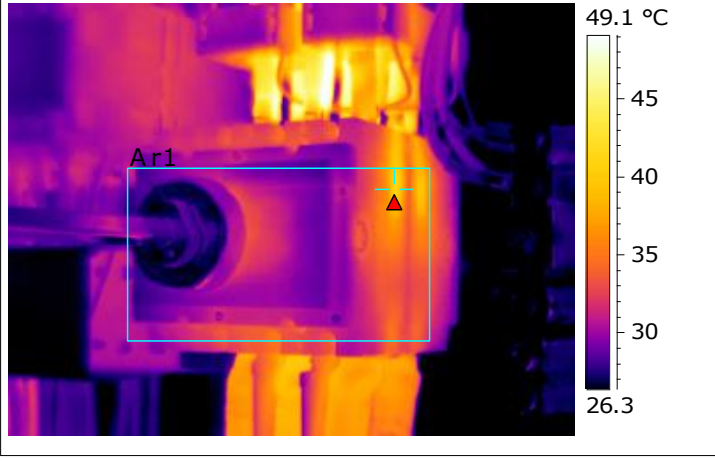
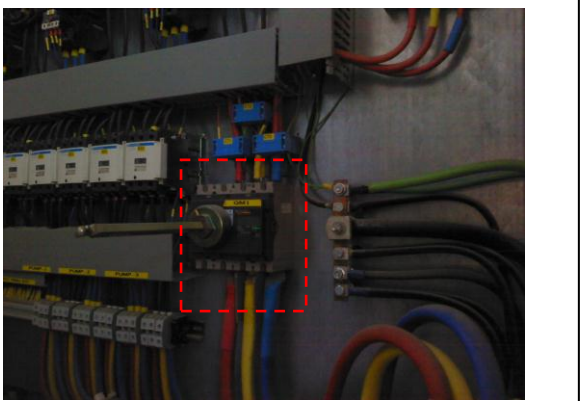
<b>Equipment</b> AGH0187/EP/EMCC-2
<b>Image File Name</b> FLIR0288.jpg		<b>Image Date</b> 2/04/2015
<b>Image Time</b> 10:35:24		
<b>Ar1 Max. Temperature</b> 41.1 °C

1 Low ( $\Delta = 5.1-10^{\circ}\text{C}$ )	To be monitored	<input type="checkbox"/>
2 Medium ( $\Delta = 10.1-35^{\circ}\text{C}$ )	Repair as soon as schedule permits	<input type="checkbox"/>	
3 High ( $\Delta > 35.1^{\circ}\text{C}$ )	Repair immediately	<input type="checkbox"/>	
<b>Analysis:</b>			
Temperature analysis is normal

<b>Corrective action:</b>	
Recommendation: Nothing to do since the temperature reading was normal	
In maximum load, this main circuit breaker (Ar1 in thermal image above shown) model reference temperature should not exceed 70 ° C (reference Standard for Infrared Inspection of Electrical System and Rotating Equipment).

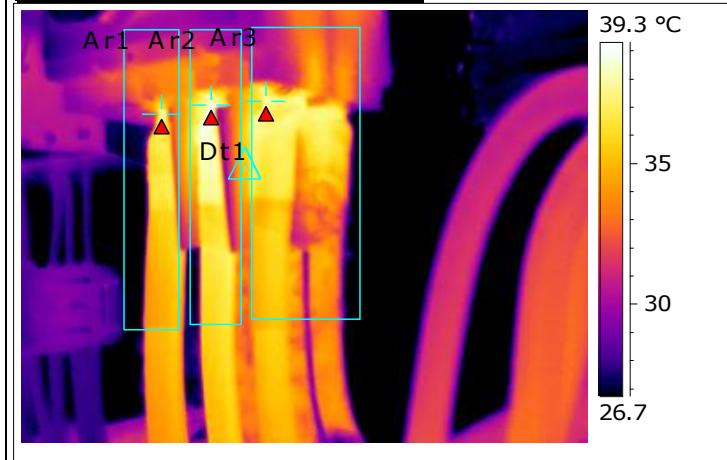
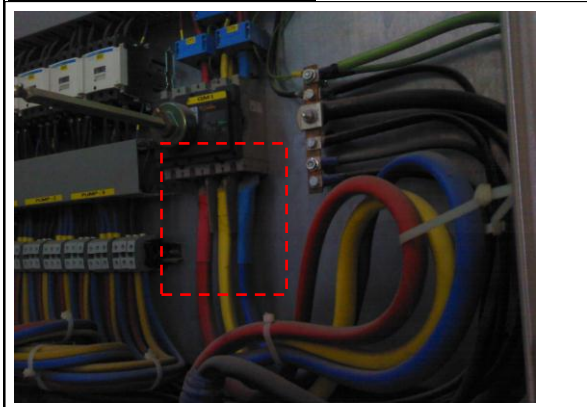
Ar1 Max. Temperature	38.2 °C
Ar2 Max. Temperature	39.6 °C
Ar3 Max. Temperature	38.0 °C
Dt1 Value	1.60 °C

Temperature analysis is normal

Recommendation: Nothing to do since the temperature reading was normal

In maximum load, these connections and terminations (Ar1, Ar2 and Ar3 in thermal image above shown) model reference temperature should not exceed  $90^{\circ}\text{C}$  (reference Standard for Infrared Inspection of Electrical System and Rotating Equipment).

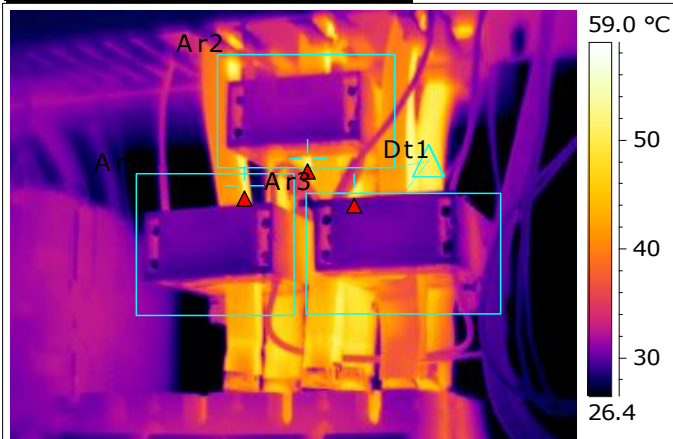
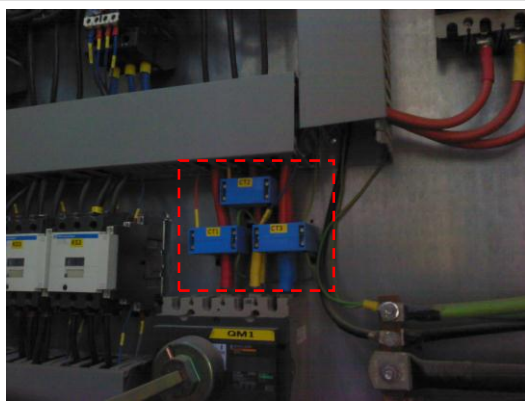
Ar1 Max. Temperature	51.8 °C
Ar2 Max. Temperature	53.8 °C
Ar3 Max. Temperature	51.5 °C
Dt1 Value	2.30 °C

Temperature analysis is normal

Recommendation: Nothing to do since the temperature reading was normal

In maximum load, these connections and terminations (Ar1, Ar2 and Ar3 in thermal image above shown) model reference temperature should not exceed 90 ° C (reference Standard for Infrared Inspection of Electrical System and Rotating Equipment).

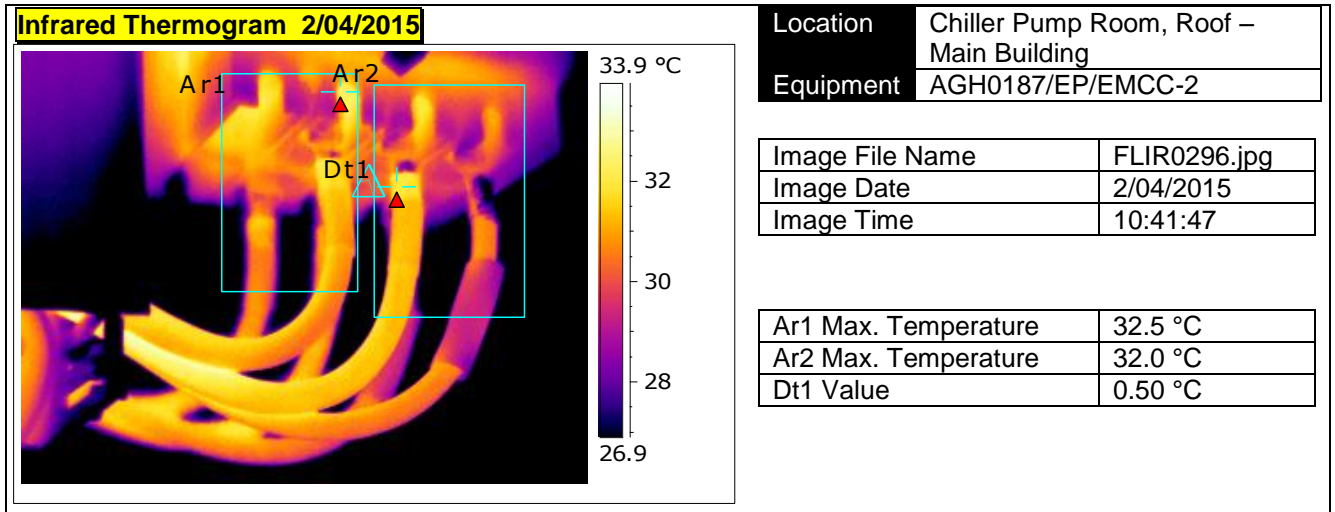
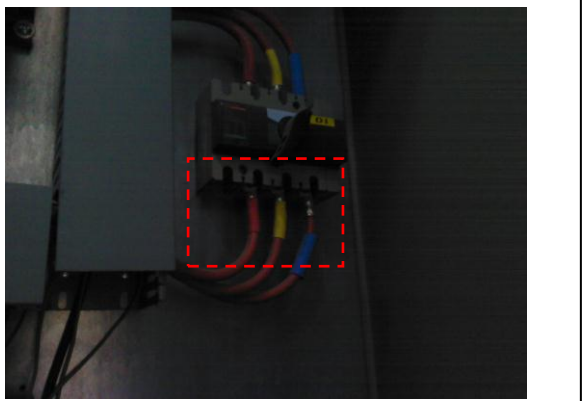
1	Low ( $\Delta = 5.1-10^{\circ}\text{C}$ )	To be monitored	<input type="checkbox"/>
		2	Medium ( $\Delta = 10.1-35^{\circ}\text{C}$ )	Repair as soon as schedule permits	<input type="checkbox"/>
		3	High ( $\Delta > 35.1^{\circ}\text{C}$ )	Repair immediately	<input type="checkbox"/>
<b>Analysis:</b>					
Temperature analysis is normal

Recommendation: Nothing to do since the temperature reading was normal

In maximum load, these connections and terminations (Ar1 and Ar2 in thermal image above shown) model reference temperature should not exceed 90 ° C (reference Standard for Infrared Inspection of Electrical System and Rotating Equipment).

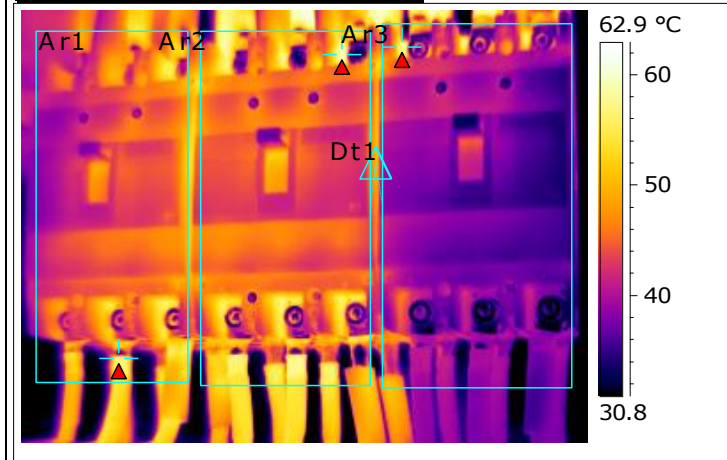
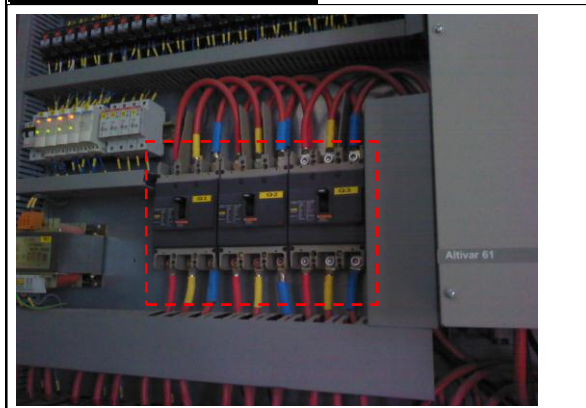
Ar1 Max. Temperature	58.2 °C
Ar2 Max. Temperature	60.4 °C
Ar3 Max. Temperature	57.9 °C
Dt1 Value	2.50 °C

Temperature analysis is normal

Recommendation: Nothing to do since the temperature reading was normal

In maximum load, these connections and terminations (Ar1, Ar2 and Ar3 in thermal image above shown) model reference temperature should not exceed 90 ° C (reference Standard for Infrared Inspection of Electrical System and Rotating Equipment).

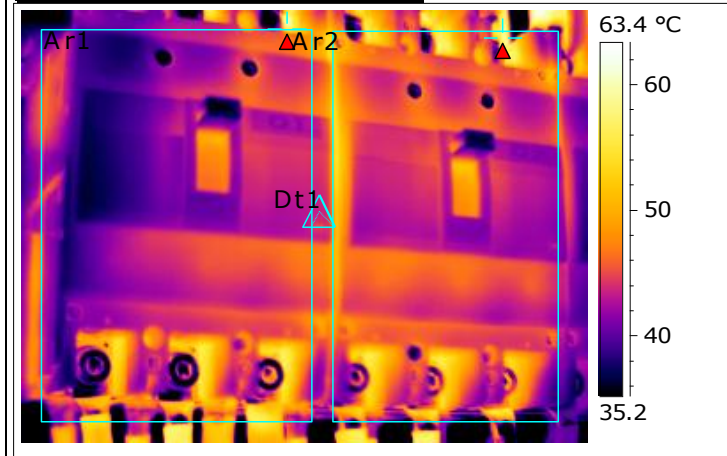
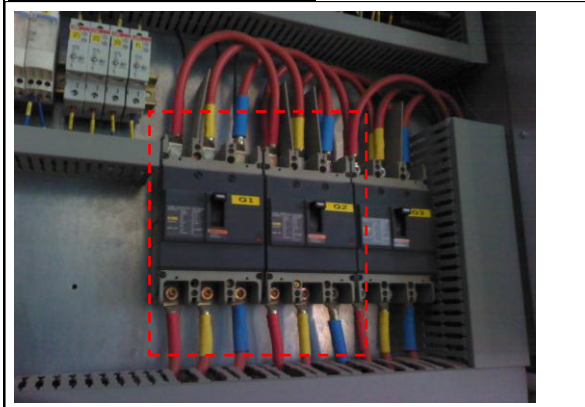
Ar1 Max. Temperature	57.3 °C
Ar2 Max. Temperature	59.7 °C
Dt1 Value	2.40 °C

Temperature analysis is normal

Recommendation: Nothing to do since the temperature reading was normal

In maximum load, these circuit breakers (Ar1 and Ar2 in thermal image above shown) model reference temperature should not exceed 70 °C (reference Standard for Infrared Inspection of Electrical System and Rotating Equipment).

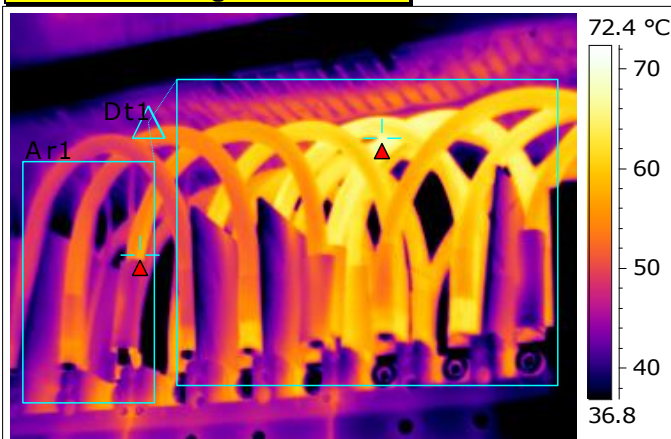
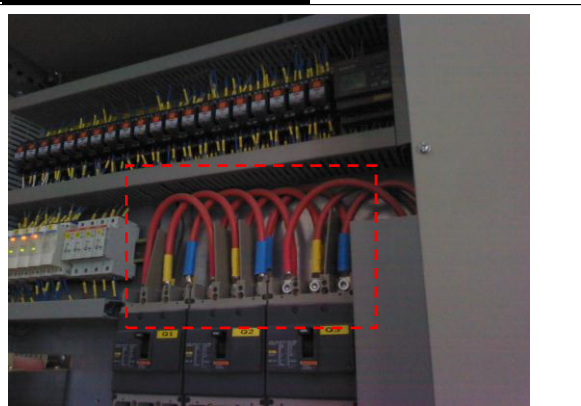
Ar1 Max. Temperature	58.0 °C
Ar2 Max. Temperature	68.5 °C
Dt1 Value	10.5 °C

1	Low ( $\Delta = 5.1-10^{\circ}\text{C}$ )	To be monitored	<input type="checkbox"/>
2	Medium ( $\Delta = 10.1-35^{\circ}\text{C}$ )	Repair as soon as schedule permits	<input checked="" type="checkbox"/>
3	High ( $\Delta > 35.1^{\circ}\text{C}$ )	Repair immediately	<input type="checkbox"/>

The 50mm<sup>2</sup> size of wire was overloaded (actual load in line 2 phase was 150 amperes) (Ar2 in thermal image above shown)

Recommendation: Replace the existing cables (Ar2 in thermal image above shown) with higher ampacity rating as necessary, (Re-termination is required, then investigate -kindly double check the balancing of load / load – torque in each line side of the cables and do another thermal inspection is needed after repair)

In maximum load, these connections and terminations (Ar1 and Ar2 in thermal image above shown) model reference temperature should not exceed 90 ° C (reference Standard for Infrared Inspection of Electrical System and Rotating Equipment).

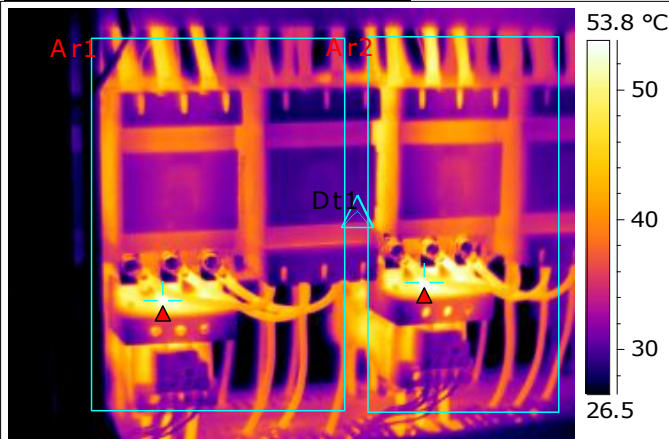
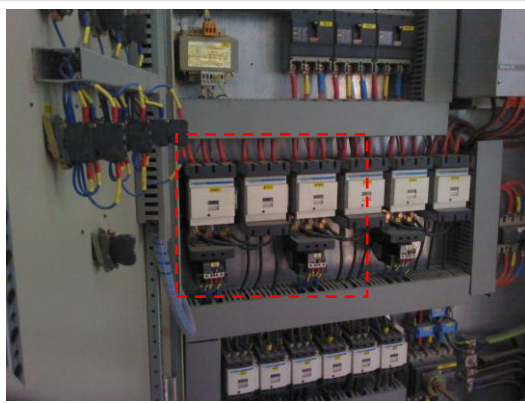
Ar1 Max. Temperature	55.0 °C
Ar2 Max. Temperature	55.7 °C
Dt1 Value	0.70 °C

Temperature analysis is normal

Recommendation: Nothing to do since the temperature reading was normal

In maximum load, these connections and terminations (Ar1 and Ar2 in thermal image above shown) model reference temperature should not exceed 90 ° C (reference Standard for Infrared Inspection of Electrical System and Rotating Equipment).

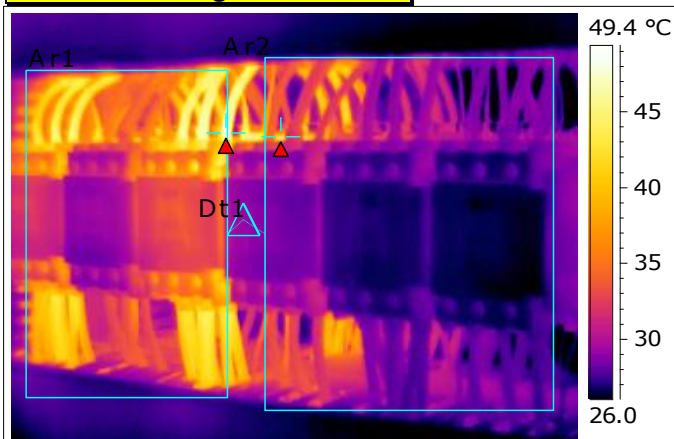
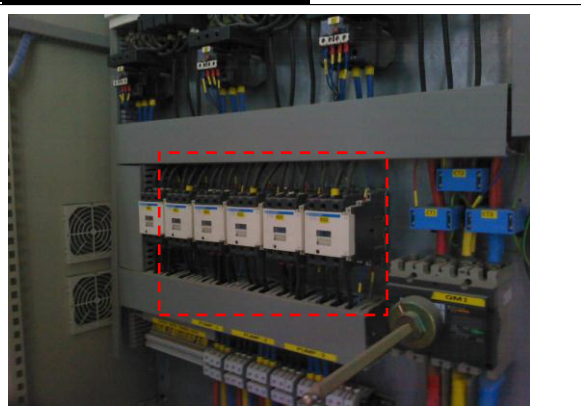
Ar1 Max. Temperature	48.5 °C
Ar2 Max. Temperature	44.2 °C
Dt1 Value	4.30 °C

Temperature analysis is normal

Recommendation: Nothing to do since the temperature reading was normal

In maximum load, these contactors (Ar1 and Ar2 in thermal image above shown) model reference temperature should not exceed  $90^{\circ}\text{C}$  (reference Standard for Infrared Inspection of Electrical System and Rotating Equipment).

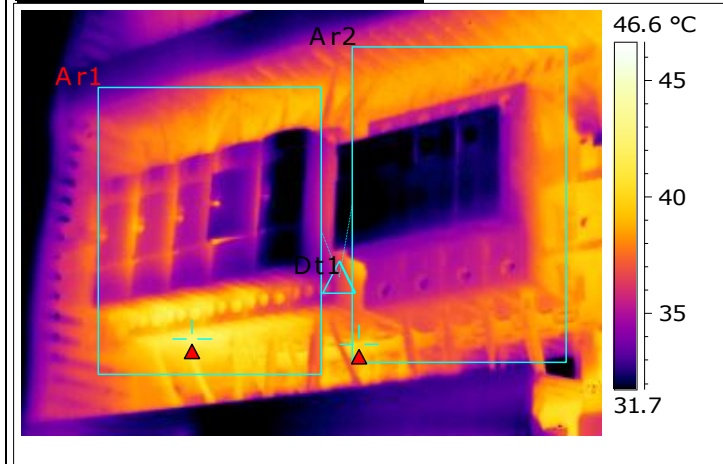
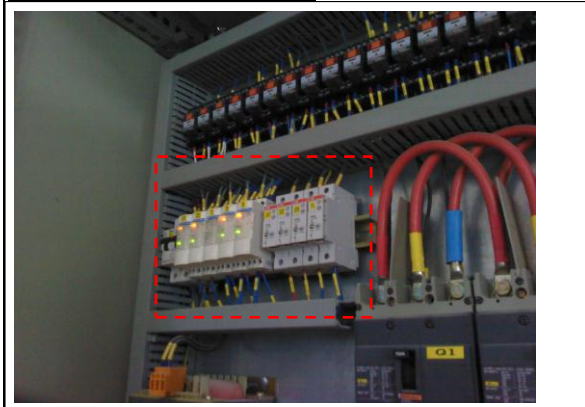
Ar1 Max. Temperature	42.5 °C
Ar2 Max. Temperature	40.1 °C
Dt1 Value	2.40 °C

Temperature analysis is normal

Recommendation: Nothing to do since the temperature reading was normal

In maximum load, these connections and terminations (Ar1 and Ar2 in thermal image above shown) model reference temperature should not exceed  $90^{\circ}\text{C}$  (reference Standard for Infrared Inspection of Electrical System and Rotating Equipment).
