**Thermal Inspection for Electrical Equipment  
Using Advanced FLIR T640 Thermal Camera  
For**

**Customer:\*\*\*\*\***

**10/11/2014**

**Engr. Adrian Arigo**

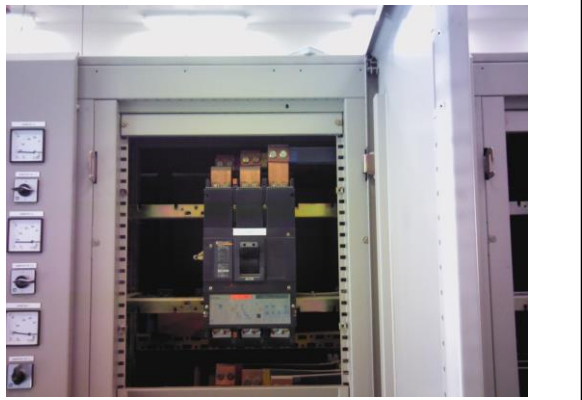
| <b>Infrared Thermogram 11/10/2014</b> | | <b>Location</b> SCECO Building EB - 028<br><b>Equipment</b> Switchgear A + B – Panelboard 1 | | | | | | | | | | |
| Ar1 Max. Temperature | 29.9 °C | | | | | | | | | | | |

| <p>In maximum load, this main circuit breaker (Ar1 of thermal image) model reference temperature should not exceed 70°C.</p> |

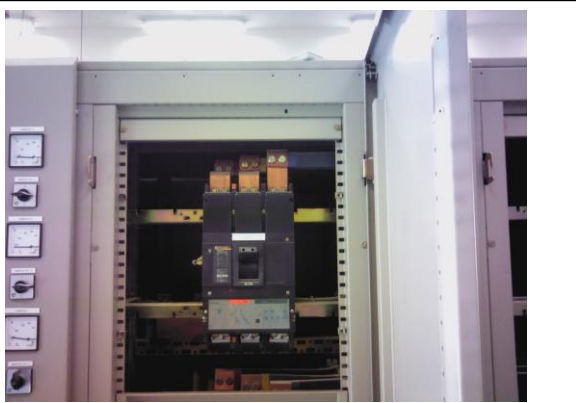
| <b>Image File Name</b> | GR_0159.jpg |

| <b>Equipment</b> | Switchgear A + B – Panelboard 1 |
| <b>Sp1 Max. Temperature</b> | 27.6 °C |
| <b>Sp2 Max. Temperature</b> | 27.2 °C |
| <b>Sp3 Max. Temperature</b> | 26.9 °C |

In maximum load, this connectors and terminations (Sp1 to Sp3 of thermal image) model reference temperature should not exceed 90°C.

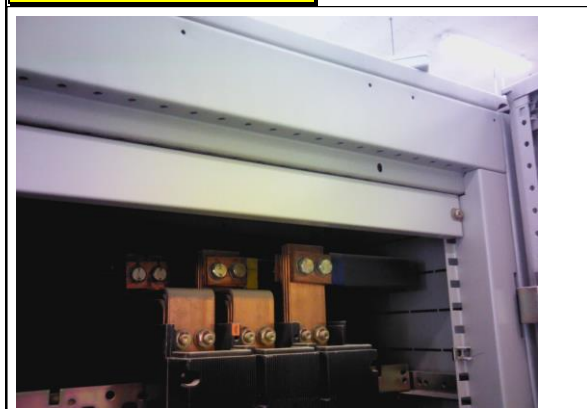
| Image File Name | GR_0161.jpg |

| Equipment | Switchgear A + B – Panelboard 1 |
| Sp1 Max. Temperature | 26.7 °C |
| Sp2 Max. Temperature | 27.4 °C |
| Sp3 Max. Temperature | 28.2 °C |

In maximum load, this connectors and terminations (Sp1 to Sp3 of thermal image) model reference temperature should not exceed 90°C.

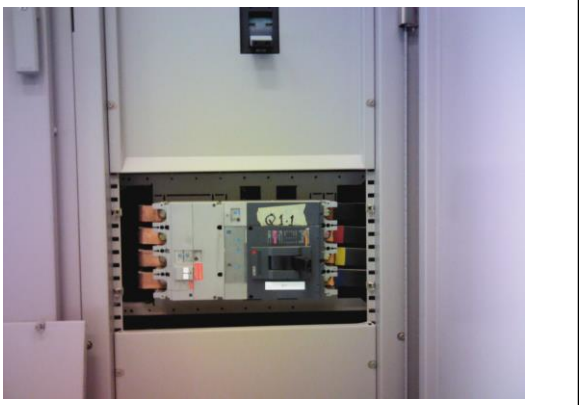
| Equipment | Switchgear A + B – Panelboard 1 | | | | | | | | | | | | | | | | | | | | |
| Ar1 Max. Temperature | 29.1 °C | | | | | | | | | | | | | | | | | | | | |

| <b>Corrective action:</b><br><p>In maximum load, this main circuit breaker (Ar1 of thermal image) model reference temperature should not exceed 70°C.</p> |

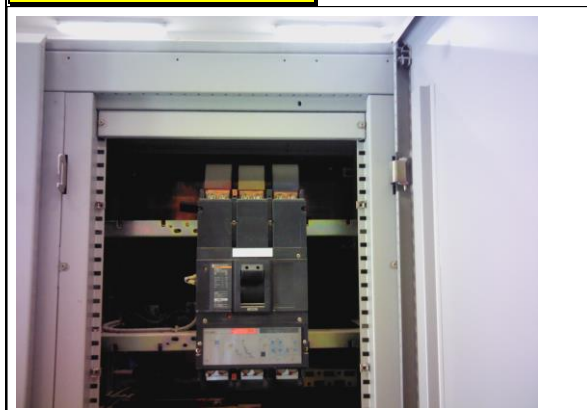
| <b>Image File Name</b> | GR_0166.jpg |

| <b>Equipment</b> | Switchgear A + B – Panelboard 2 |
| <b>Ar1 Max. Temperature</b> | 28.4 °C |

In maximum load, this main circuit breaker (Ar1 of thermal image) model reference temperature should not exceed 70°C.

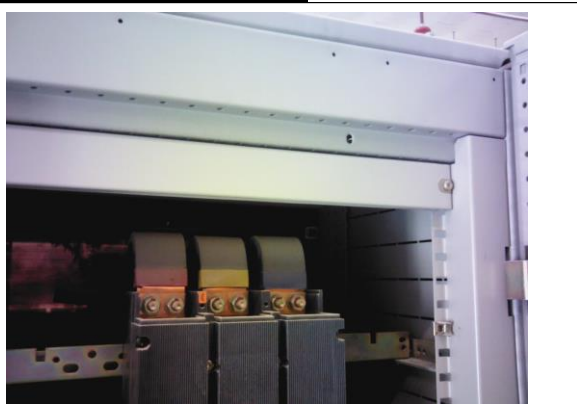
| Image File Name | GR_0168.jpg |

| <b>Equipment</b> | Switchgear A + B – Panelboard 2 |
| Sp1 Max. Temperature | 26.9 °C |
| Sp2 Max. Temperature | 27.7 °C |
| Sp3 Max. Temperature | 27.5 °C |

In maximum load, this connectors and terminations (Sp1 to Sp3 of thermal image) model reference temperature should not exceed 90°C.

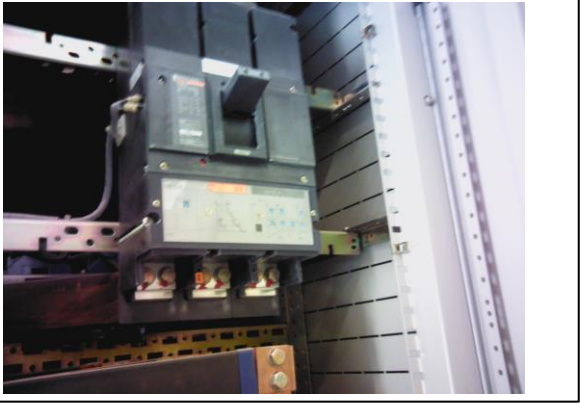
| Equipment | Switchgear A + B – Panelboard 2 | | | | | | | | | | | | | | | | | | | | | | | | |
| Sp1 Max. Temperature | 27.2 °C | | | | | | | | | | | | | | | | | | | | | | | | |
| Sp2 Max. Temperature | 27.9 °C | | | | | | | | | | | | | | | | | | | | | | | | |
| Sp3 Max. Temperature | 26.4 °C | | | | | | | | | | | | | | | | | | | | | | | | |

| <b>Corrective action:</b><br><p>In maximum load, this connectors and terminations (Sp1 to Sp3 of thermal image) model reference temperature should not exceed 90°C.</p> |

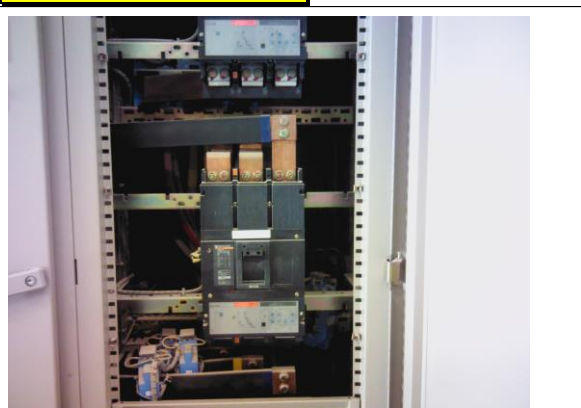
| Image File Name | GR_0172.jpg |

| Equipment | Switchgear A + B – Panelboard 2 |

| Ar1 Max. Temperature | 28.7 °C |

In maximum load, this main circuit breaker (Ar1 of thermal image) model reference temperature should not exceed 70°C.

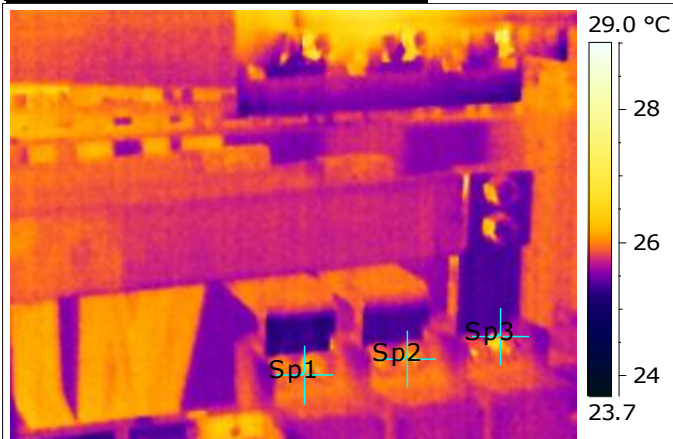
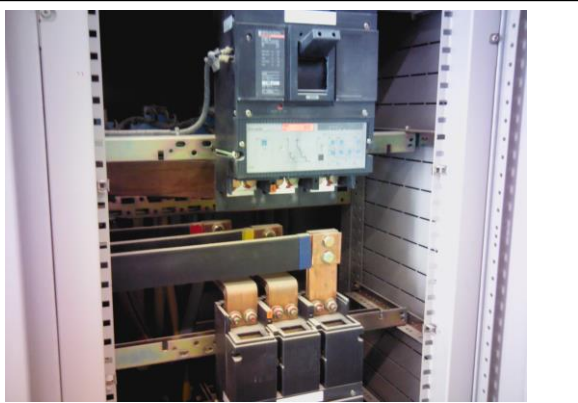
| Image File Name | GR_0174.jpg |

| Equipment | Switchgear A + B – Panelboard 2 |
| Sp1 Max. Temperature | 26.0 °C |
| Sp2 Max. Temperature | 25.9 °C |
| Sp3 Max. Temperature | 25.9 °C |

In maximum load, this connectors and terminations (Sp1 to Sp3 of thermal image) model reference temperature should not exceed 90°C.

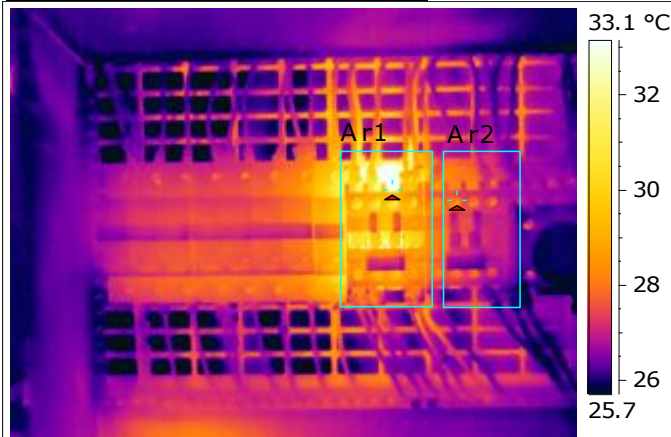
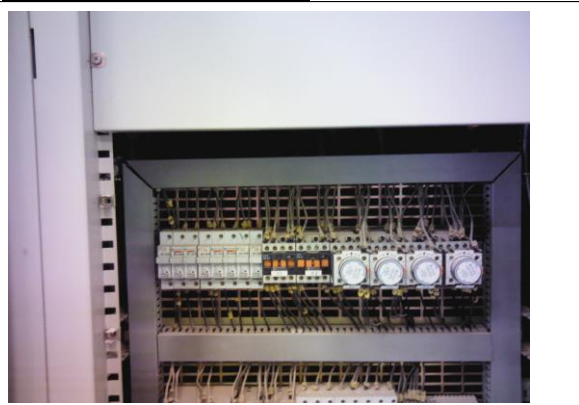
| Equipment | Switchgear A + B – Panelboard 3 |

| Ar2 Max. Temperature | 29.6 °C |
